Water Pollution Source Tracking

City of Santa Barbara

**Source
Tracking
Protocol**
- human waste

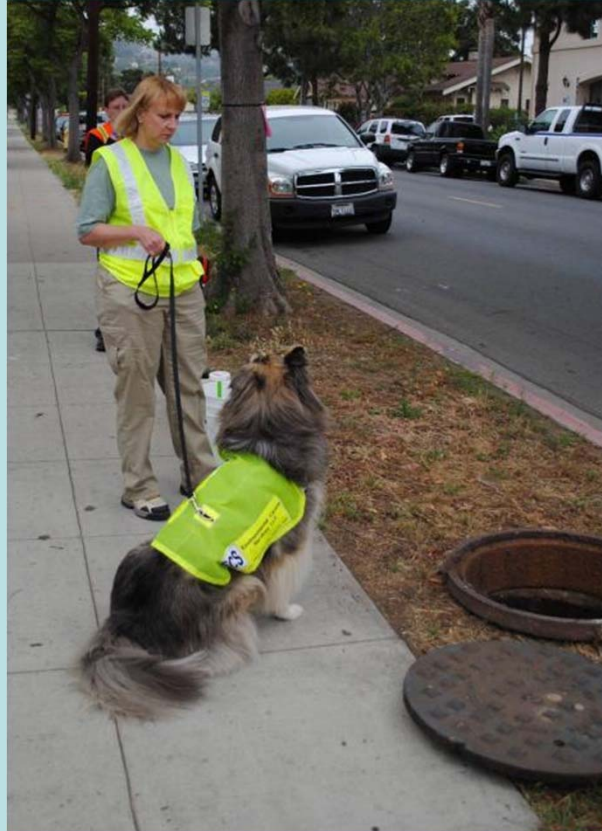
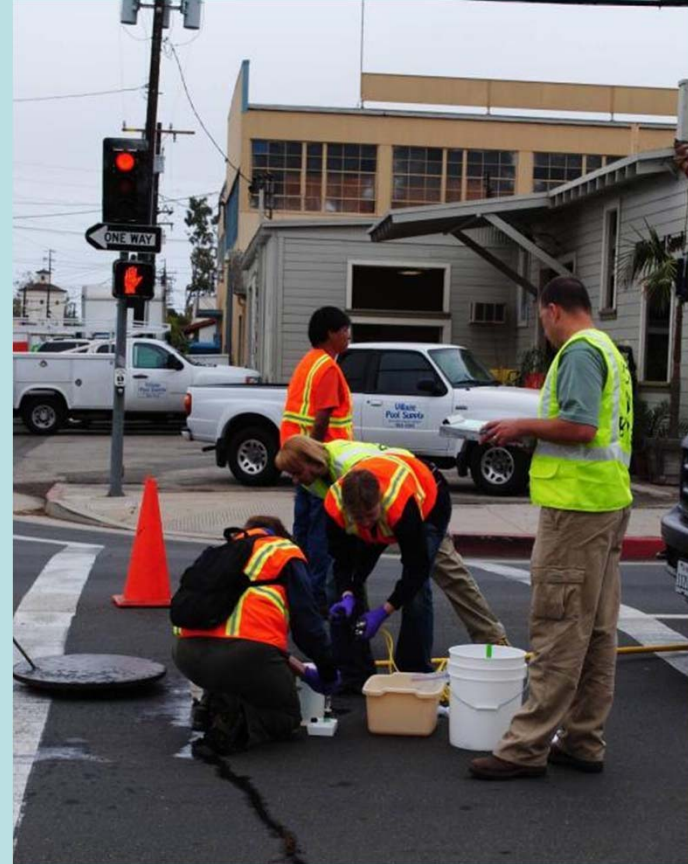
Tracking Methods: Sewage Sniffing Dogs

Environmental Canine Services, LLC

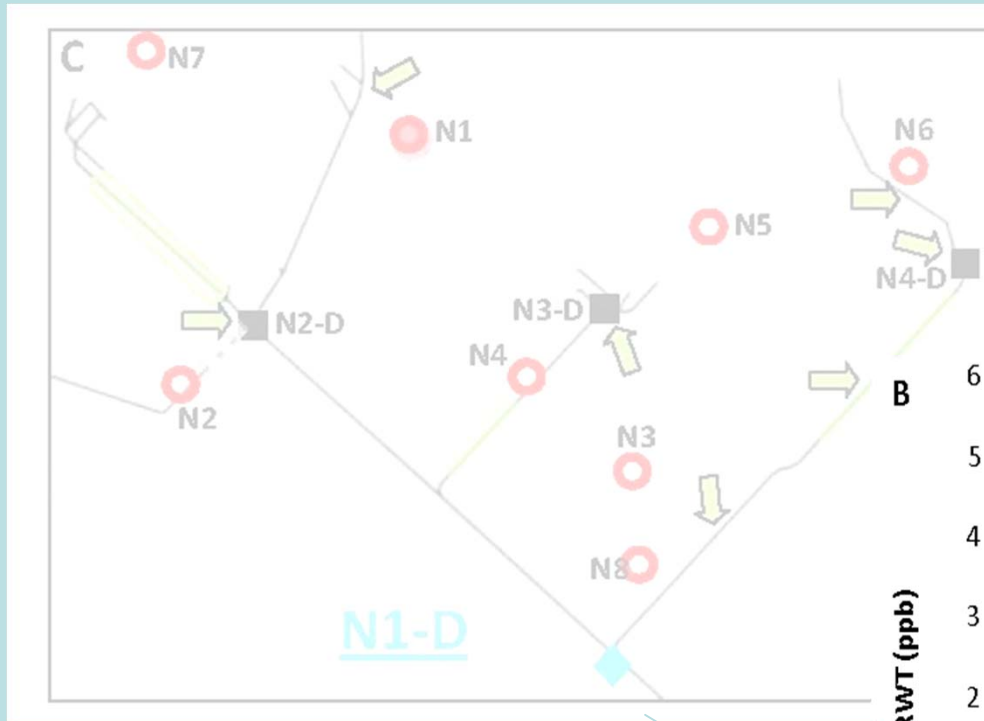
Nopal St. Storm Drain

Dye in Sanitary Sewer

Probe in Storm Drain

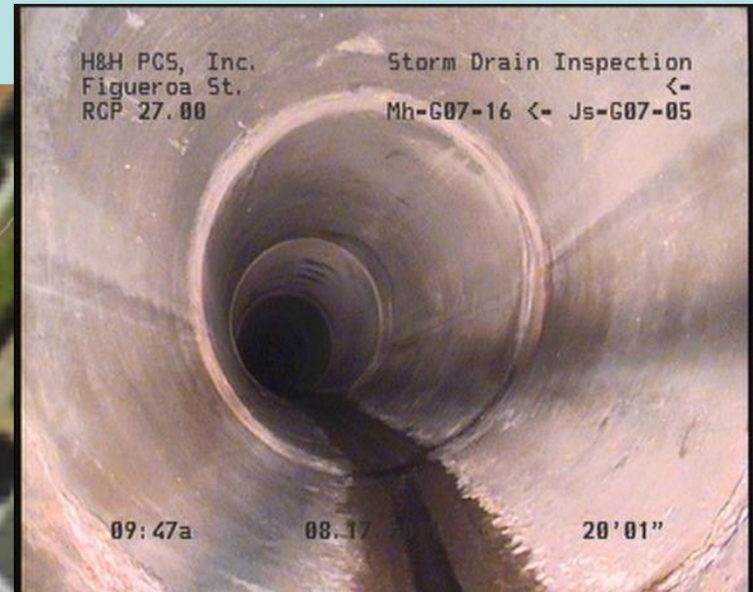
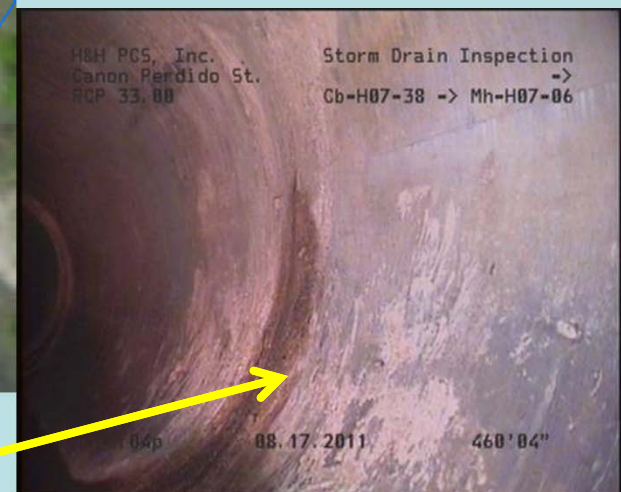
Nopal St. Storm Drain

Typical Groundwater Infiltration

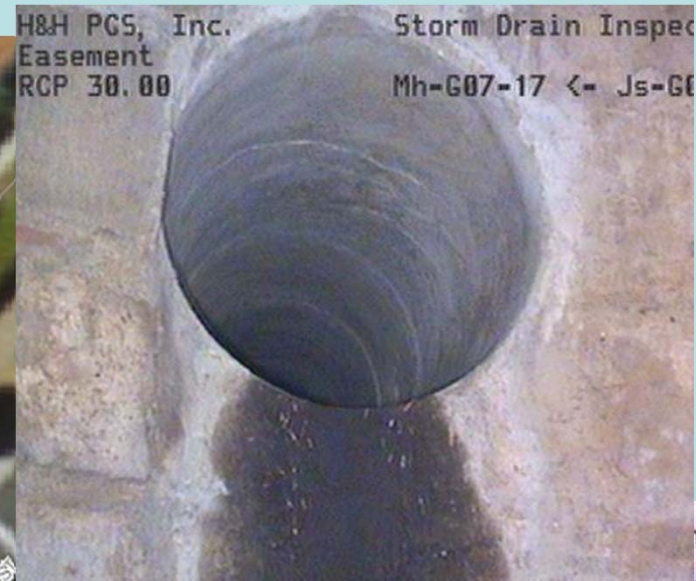
Nopal St. Storm Drain

H&H PCS, Inc.
Easement
RCP 30.00

Storm Drain Inspe
Mh-G07-17 <- Js-G0

RCP 27.00

Mh-G07-16 <- Mh-G1

Sewage Infiltration

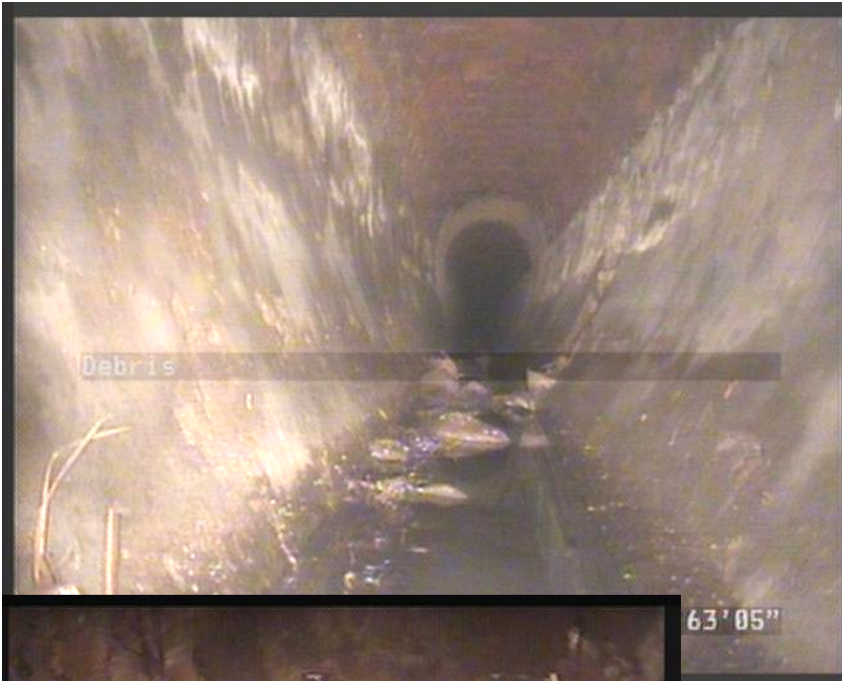
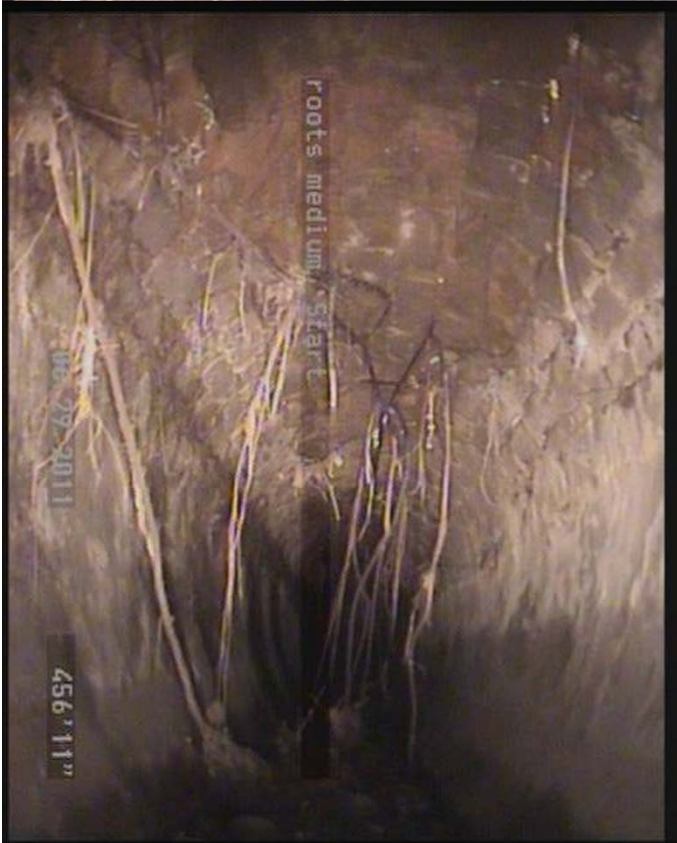
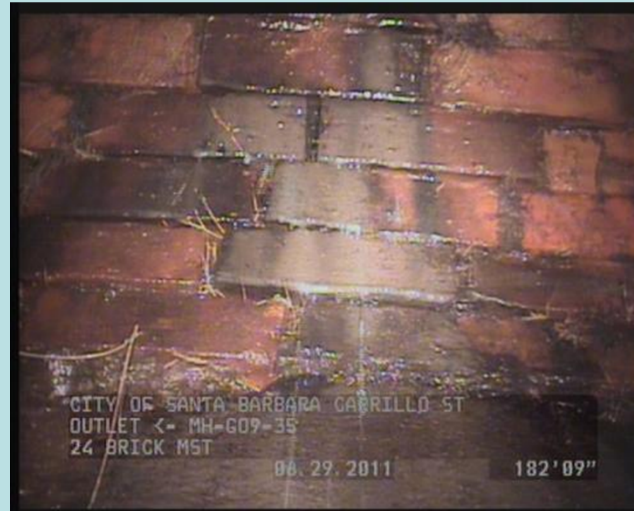
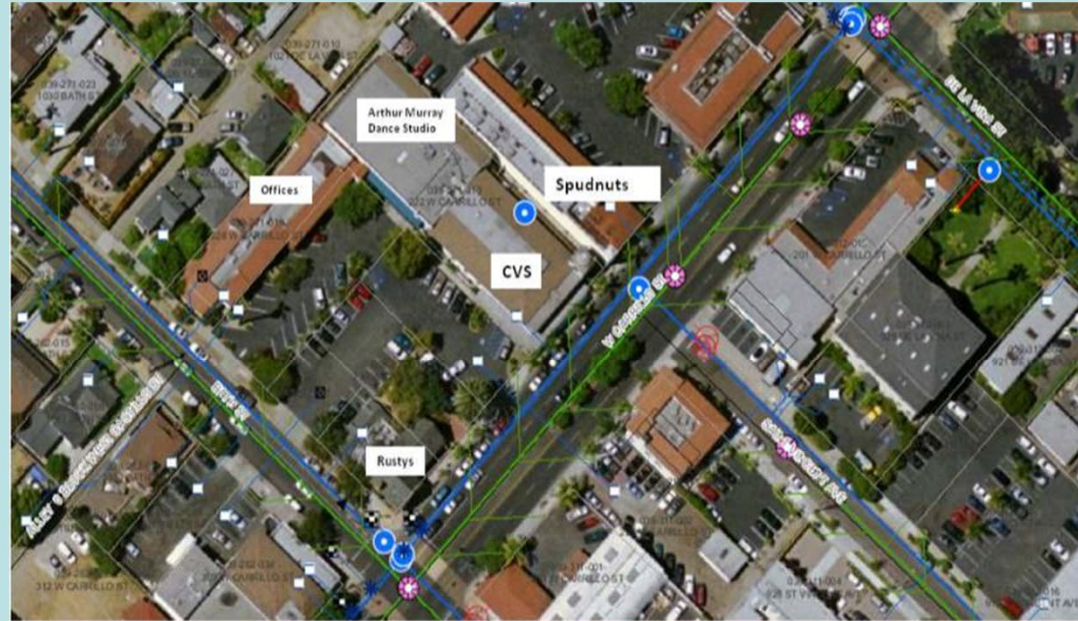
Carrillo St. Storm Drain

- Many years of high FIB, smell.
- Sporadic hits for human waste markers.
- Early CCTV work inconclusive.
- Recent CCTV showed water dripping into storm drain.
- Crack did not appear large.
- Dye testing of toilets in nearby businesses, camera in storm drain.

Two private laterals to 6 businesses
